KEY FINDINGS

PHASE I

ENVIRONMENTAL

H.J.E. Wenckenbachweg

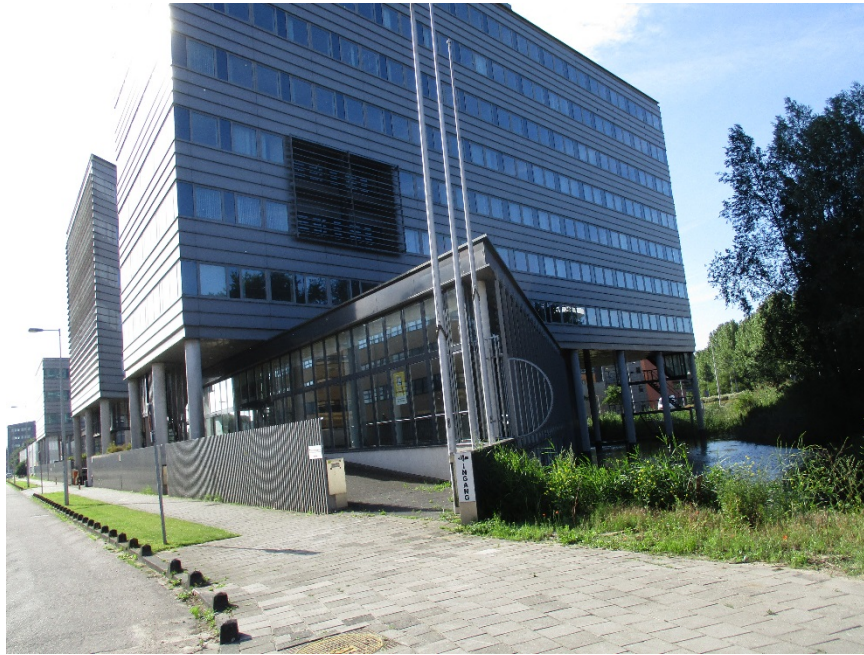
Photo 1

View towards south west, subject plot improved with office building consisting of three towers (eight storey front tower A, six storey middle B and four storey lowest tower respectively).

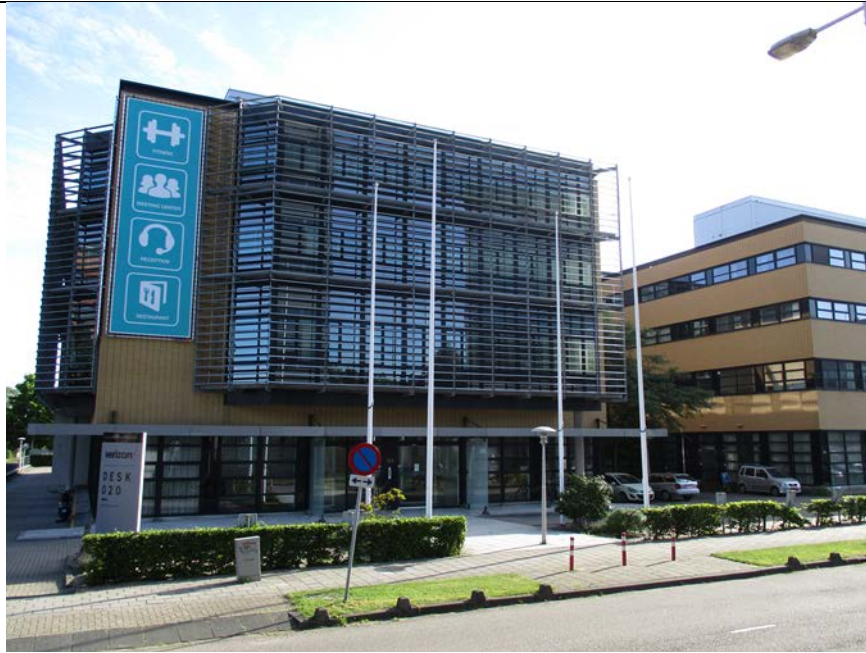
Photo 2

View towards the northeast, site building viewed from roundabout between *H.J.E. Wenckenbachweg* road and *Joop Geesingweg* road.

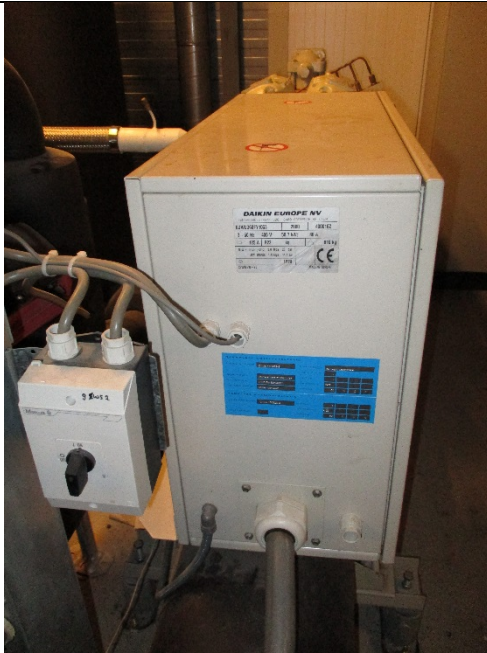
Photo 5.

Example of cooling equipment in plant room on seventh floor of building tower A (containing coolant R22).

Based on the site visit, there are six small condensers on site which have R22 refrigerant, two units serving each tower. R22 is an ozone depleting substance. It is important to note that the manufacture and re-cycling of ozone depleting substances used in air conditioning and cooling equipment has been banned since 2015, under EU Regulation EC 2037/2000 and 1804/2003. The use of equipment with R22 coolant is currently not prohibited, however in the event of equipment breakdown it cannot be refilled and replacement would be required.

- The cooling equipment at site contains R22 coolant (six items), the manufacture and re-cycling of ozone depleting substances used in air conditioning and cooling equipment has been banned since 2015, under EU Regulation EC 2037/2000 and 1804/2003. The use of equipment with R22 coolant is currently not prohibited, however in the event of equipment breakdown it cannot be refilled and replacement of the cooling equipment would be required thus requiring an investment.

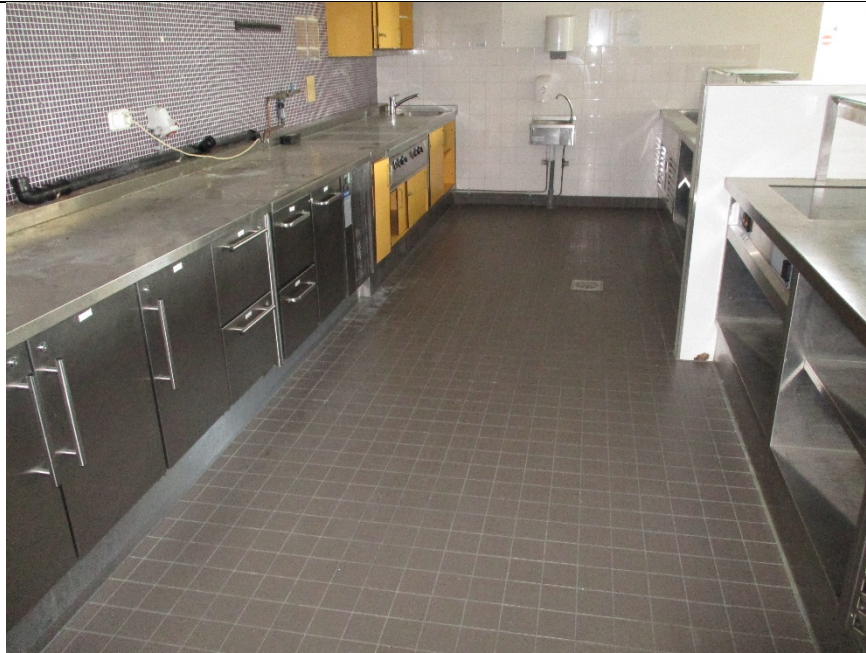
Photo 7. View of kitchen in canteen, unclear if site contains a grease trap.

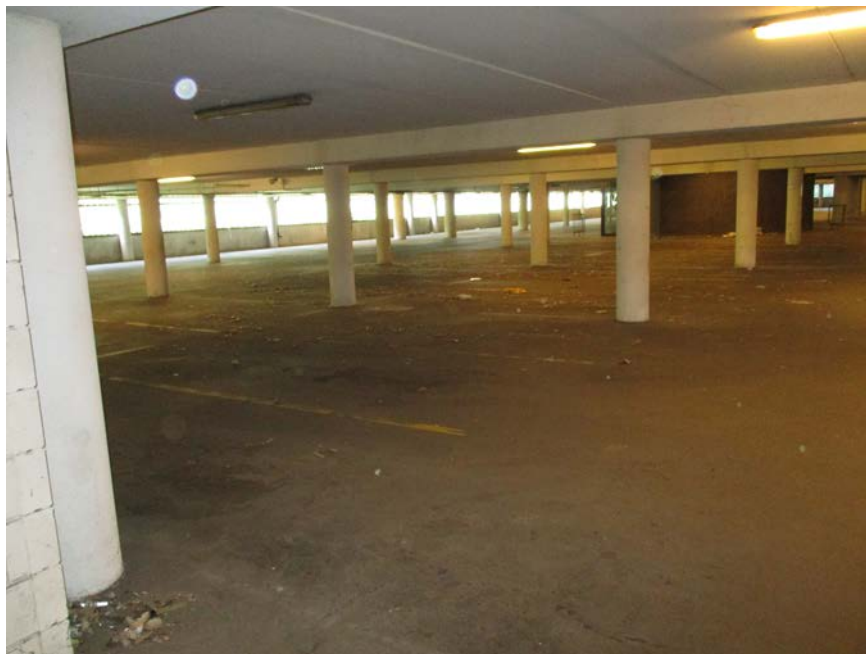
Photo 8. View of basement parking underlying all three towers of the office building.
